CEQA Historic Resources Report East Gateway Project Santa Paula, CA

14 October 2011

Executive Summary

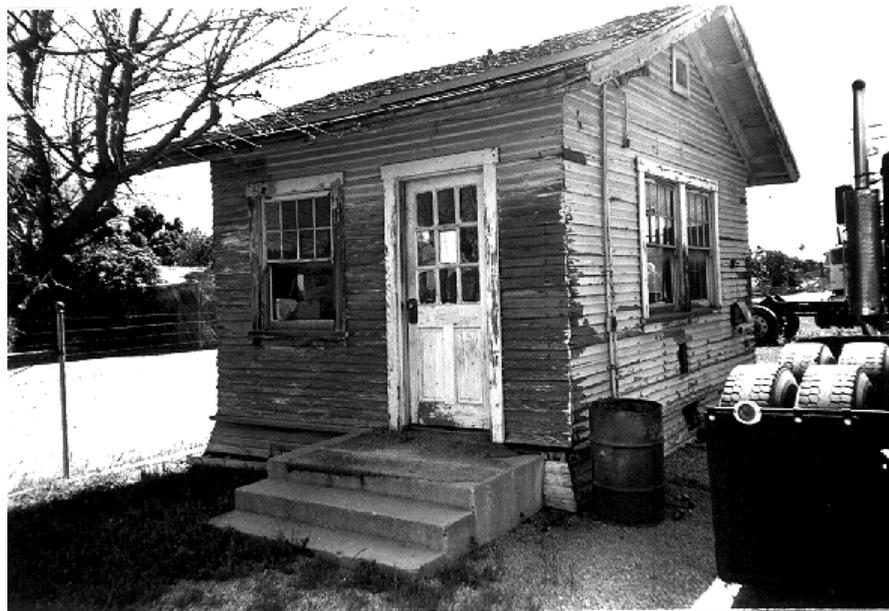
P5b. Description of Photo: (View, date, accession #)
office building (View toward west). Photo No: 1-18, 3/23/98

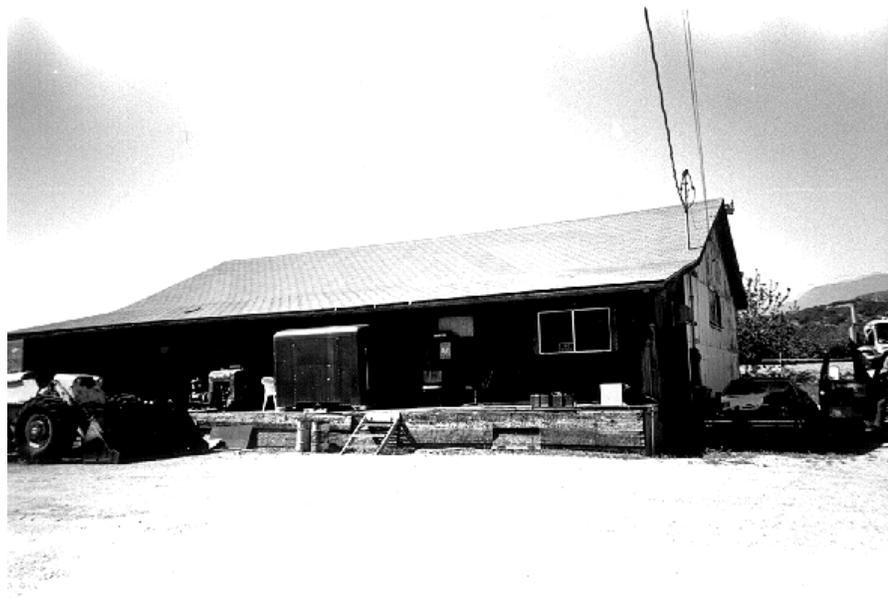
This large rectangular plan warehouse building has a medium side gable roof covered with composition shingles. On the south side of the building the roof extends out over a wooden platform. A pair of aluminum windows have been added and two smaller openings have been boarded up. There are two loading doors on the north side of the building and a pair of windows under the gable on the east and west sides. The building is covered with vertical board siding on the south elevation and with corrugated metal siding on the remaining three sides of the building. The building is in fair condition.

Description of Photo: (View, date, accession #)
*warehouse (View toward north). Photo No:
1-19, 3/23/98*

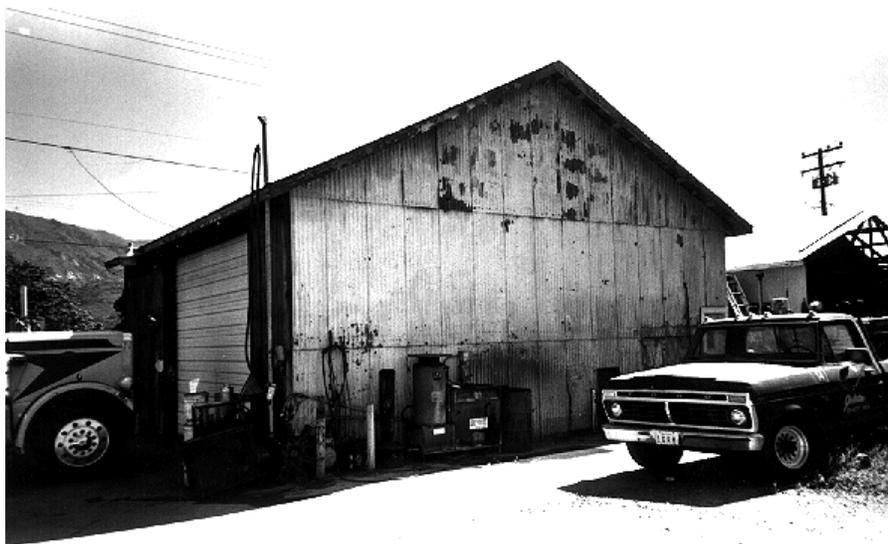
This tall square plan building has a medium gable roof covered with corrugated metal. The east, west and north sides of the building are also covered with corrugated metal sheets. A metal roll-up door is located on the south elevation. This side of the building has been changed with the addition of the door and wood siding. The building is in fair condition.

Description of Photo: (View, date, accession #)
*storage shed (View toward west). Photo No:
1-20, 3/23/98*

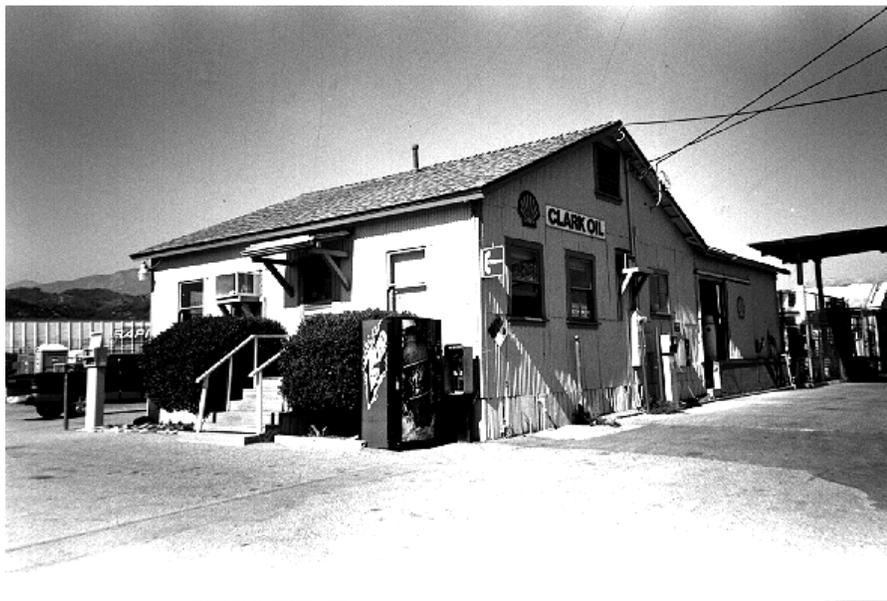
Sanborn Maps from 1929 indicate the rear portion of the building was originally open and served as a platform. It is uncertain when the corrugated metal walls were added. The building is in good condition. North of the buildings is a railroad spur and seven steel oil storage tanks.

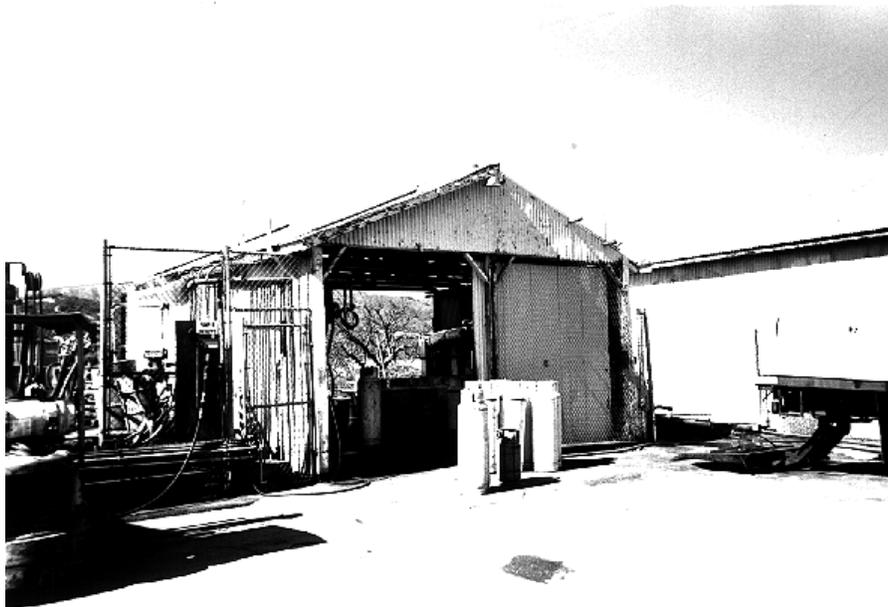
This rectangular plan one story wood frame building has a low pitched gable roof and is covered with corrugated metal siding. Both gable ends of the building are open and contain sliding track doors. The building is in fair condition.

Description of Photo: (View, date, accession #)
*shed (View toward northeast). Photo No:
1-22, 3/23/98*

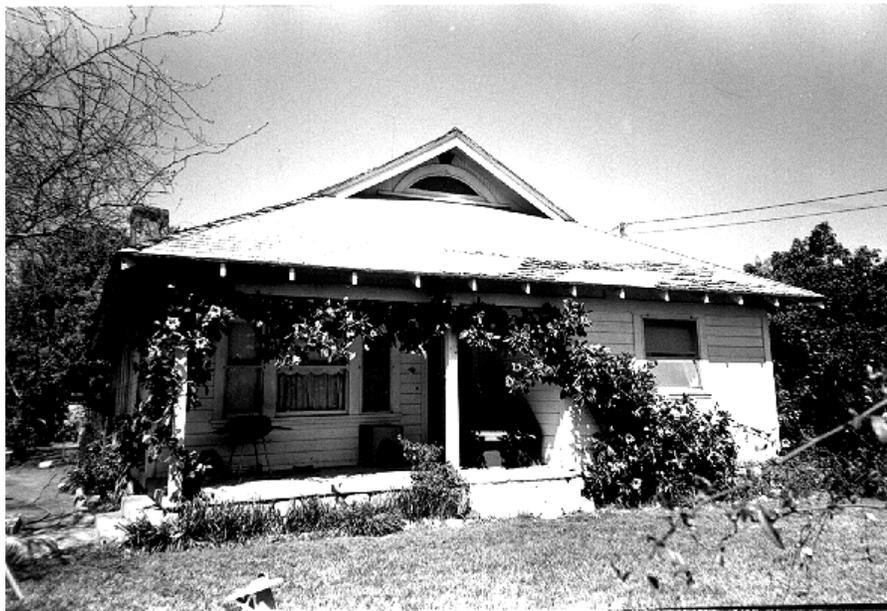
Located on a 2.08 acre site, this one-story residence is rectangular in plan with a medium pitched hipped gable roof covered with composition shingles. Rafters are exposed under the eaves. Under the gable end is a semi-circular vent. The porch is recessed on the left (west) side of the house and is supported by two square capped posts. The wood windows are single, in pairs or in threes and are one-over-one double hung or fixed with plain wood casings. The house is covered with wide horizontal shiplap siding and rests on a stone foundation. A brick chimney punctuates the roofline on the west side of the house. The interior fireplace is made of Sespe stone. Sespe stone is also found on two entry columns at Telegraph Road. The house is in good condition.

Surrounded by citrus and avocado trees, the house is set back from the road. A front lawn contains several trees and foundation plantings. A wooden water tower and several sheds are located at the rear of the property.

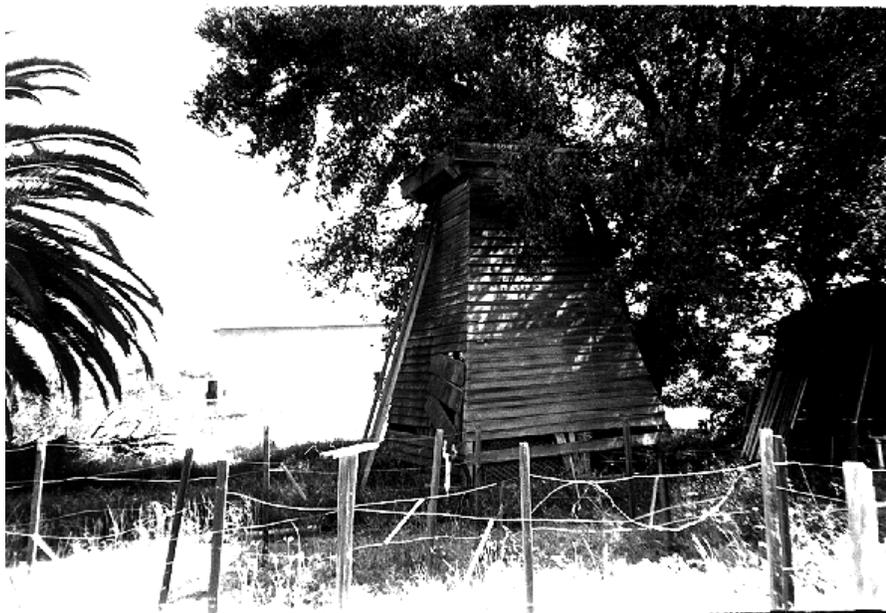
This tapered wood water tower once held a water tank. It is constructed of medium wide horizontal clapboards and has a wood platform at the top. The tower is deteriorated with boards missing. A small shed and oak tree are located adjacent to the tower.

Description of Photo: (View, date, accession #)
*water tank (View toward east). Photo No:
1-12, 3/23/98*

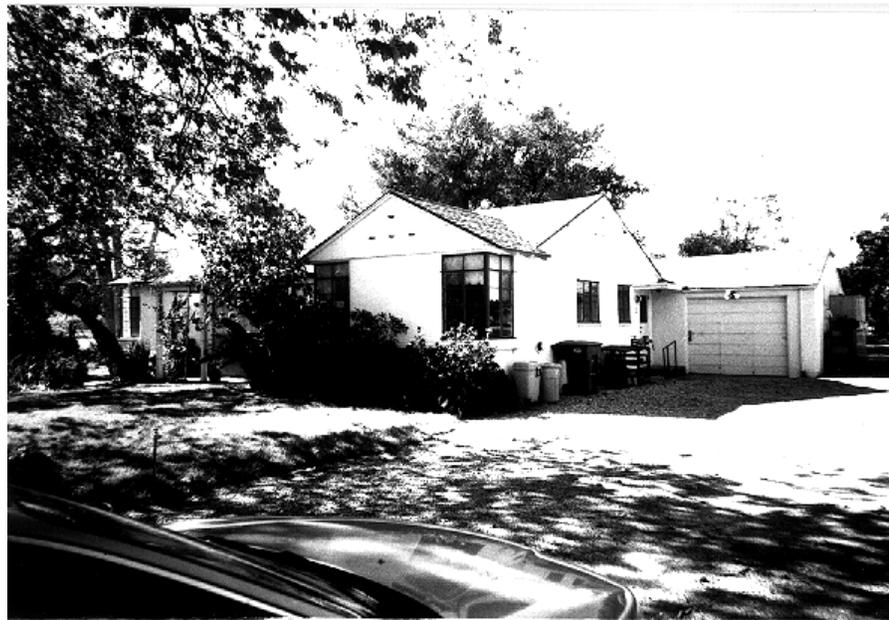
Located on a 1.03 acre site, this one story L-plan Ranch style residence has a main sidelacing medium pitched gable roof with an intersecting front gable on the right (east) side. Rafters are exposed under the eaves and the roof is covered with composition shingles. The projecting front porch is supported by decorative wood columns. Multipaned steel casement windows wrap around the corners and also are found on the sides of the house as well. The house is covered with stucco except for wide vertical board siding under the gable ends and the porch area. A single car garage is attached to the northwest corner of the house. The house is in good condition and appears to have retained its architectural integrity.

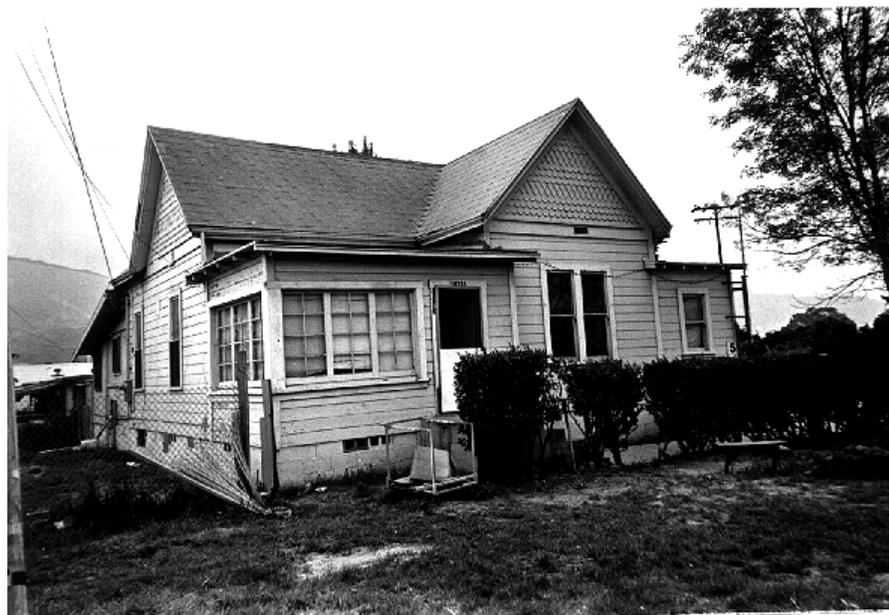
The high pitched cross gable & hip roof of this one story Folk Victorian residence features decorative shingles under the gable roofs. Both fishscale and diamond patterned shingles are found under the boxed eaves. Windows are both narrow and wide one-over-one double-hung with plain wood casings arranged individually or in pairs. The house is covered with wide horizontal shiplap siding and rests on a raised concrete block foundation. Additions to the house include a flat roofed enclosed porch with multi-paned windows and wide horizontal shiplap siding. A shed roof addition is located on the west side of the house. A shed roof addition runs across the back of the house and is covered with vertical board siding.

The house is in fair condition and has lost a portion of its integrity of design with the numerous out-of-scale additions. However, the basic original plan of the house is intact. The house is located on a 1.2 acre parcel and contains numerous small residences that have been moved on the rear of the lot.

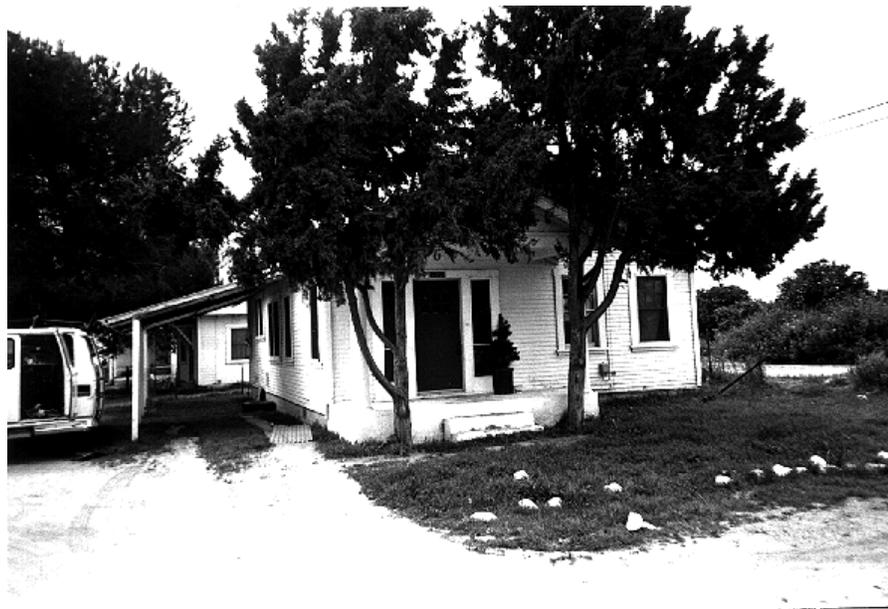
This one-story California Bungalow style residence has a rectangular plan with a front-facing medium gable roof covered with composition sheeting. The eaves are open and the projecting gable roofed porch is located on the left side of the house and is supported by capped columns. Windows are six-over-one doublehung with plain wood casings. The wood front door has six inset beveled glass panes. Adjacent to the front door are long narrow multi-paned windows. The house is covered with narrow horizontal clapboard siding and rests on a concrete block foundation. A shed roof carport is attached to the east side of the house. The house is in fair condition and has retained its architectural integrity.

Description of Photo: (View, date, accession #)
*residence (View toward south). Photo No:
1-3, 3/13/98*

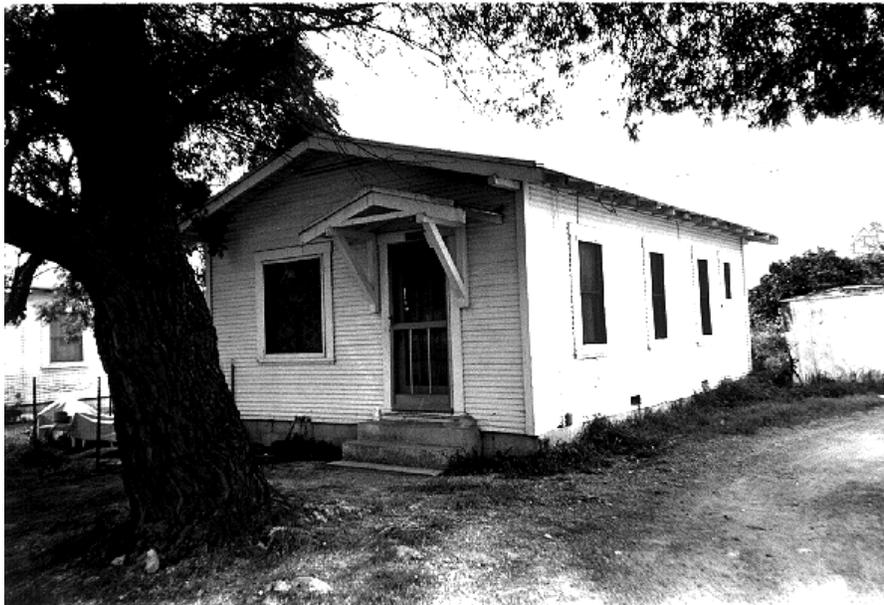
This simple California Bungalow style residence has a front facing gable roof with exposed rafters and beams under the broad eaves. The simple rectangular plan features a small gable roof over the front entrance supported with large wood brackets. A french door is located directly above the concrete stoop. The house is covered with narrow horizontal wood siding and rests on a concrete block foundation. Windows are medium one-over-one double hung with plain wood casings. The house is in good condition and has retained its architectural integrity.

Description of Photo: (View, date, accession #)
*residence (View toward west). Photo No:
1-4, 3/13/98*

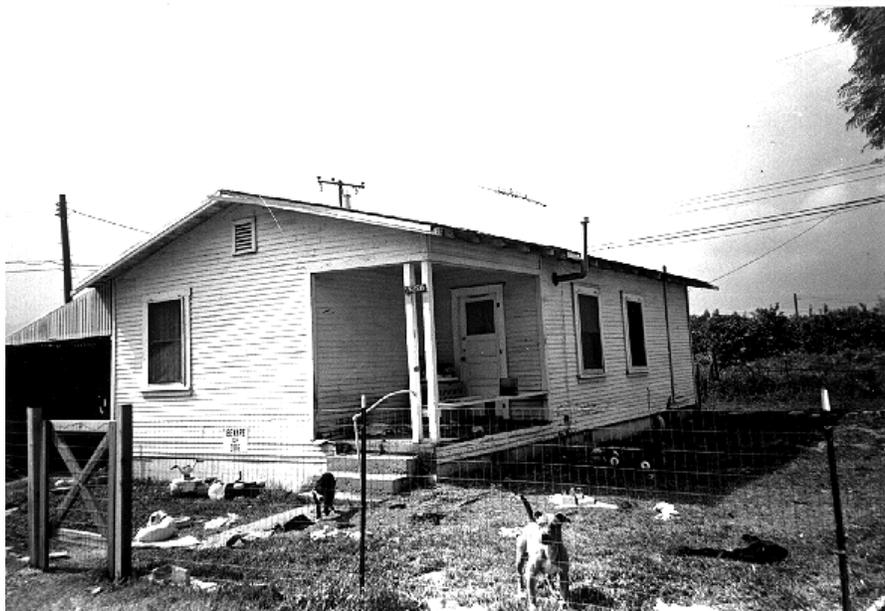
This one-story California Bungalow residence is rectangular in plan and features a recessed porch on the right side of the house. Two square posts serve as supports. The low front gable roof has exposed rafter tails. A small horizontal vent is located under the gable peak. Windows are medium one-over-one with wood casings. The house is covered with narrow horizontal clapboard siding and rests on a concrete block foundation. The house is in fair condition and has retained its architectural integrity.

Description of Photo: (View, date, accession #)
*residence (View toward west). Photo No:
1-5, 3/13/98*

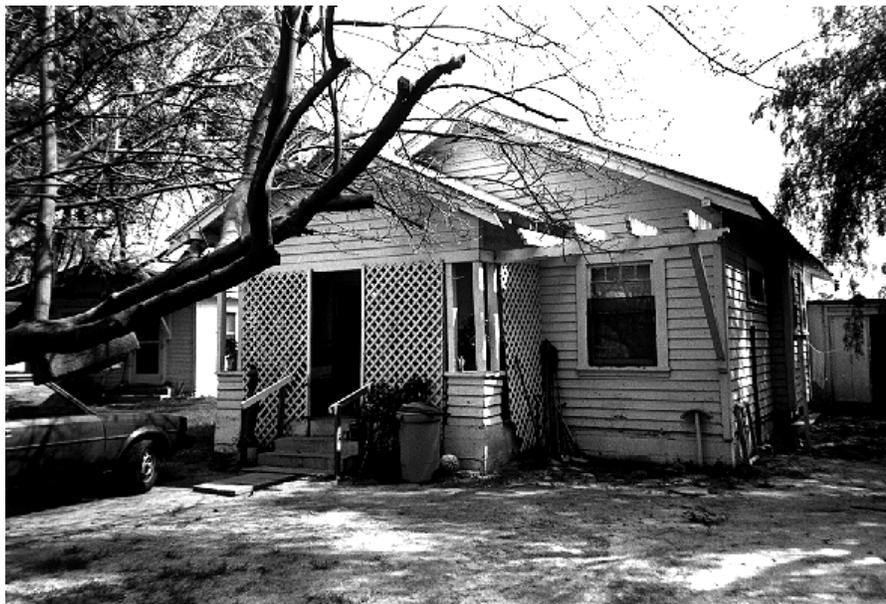
This one story front gable residence features an offset front porch with a front gable roof supported by three square posts at each corner and an enclosed porch railing. Exposed beams and rafter tails are found under the eaves. Notched beams extend from the front of the house to form a pergola across the right side of the house. Basically rectangular in plan, the house is covered with medium horizontal clapboard siding and rests on a concrete block foundation. Windows are medium sized and double hung with four small panes in the upper portion of the front window. Simple wood casings surround the windows. A wooden trellis has been added to the front porch. The house is in fair condition and has retained its integrity except for a few minor modifications.

Description of Photo: (View, date, accession #)
*residence (View toward east). Photo No:
1-6, 3/13/98*

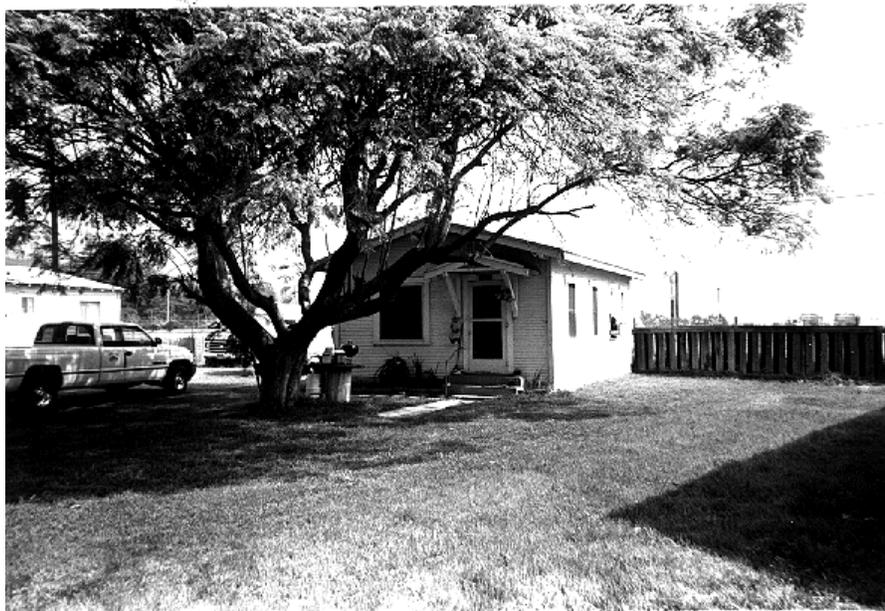
This house is identical to 18216 E. Telegraph Road. It is a simple California Bungalow residence with a low front gable roof, attached porch gable with brackets, narrow clapboard siding and double hung wood windows with plain wood casings. It is in fair condition and has retained its architectural integrity.

Description of Photo: (View, date, accession #)
residence (View toward east). Photo No:
1-7, 3/13/98

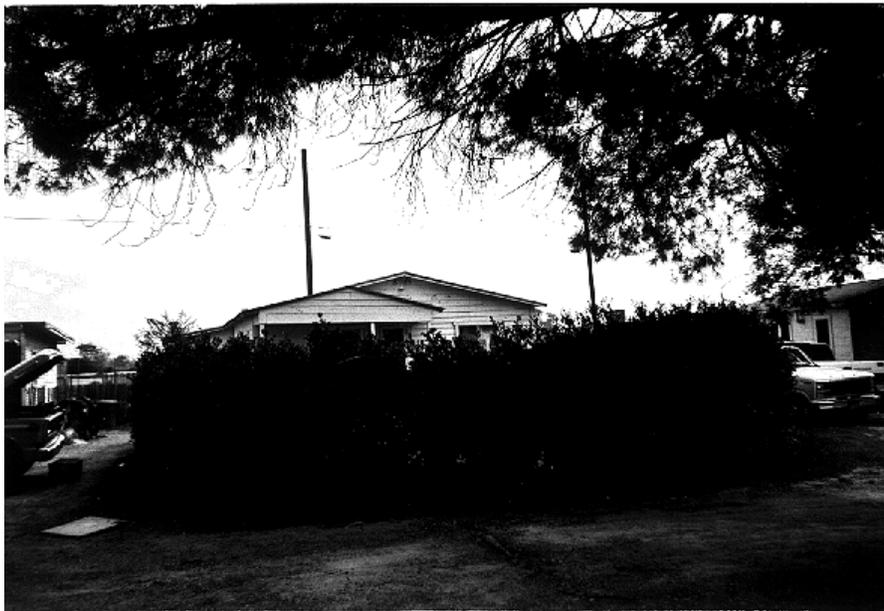
This house is rectangular in plan with a low pitched front gable roof and an offset front porch supported by square posts. Windows are aluminum sliders with plain wood casings. The house is covered with wide horizontal wood siding and rests on a concrete perimeter foundation. The house is in fair condition and has lost a portion of its architectural integrity with changes to windows.

Description of Photo: (View, date, accession #)
residence (View toward east). Photo No:
1-8, 3/13/98

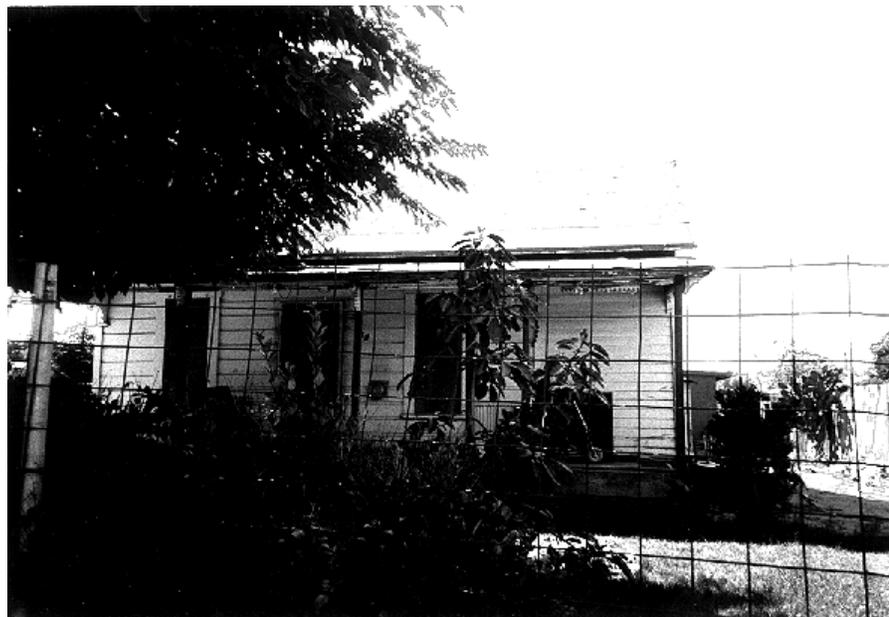
Rectangular in plan, this one-story Folk Victorian residence has a saltbox roof consisting of a medium pitched side gable in front and a long sloping side gable roof in back. The roof is covered with composition sheeting and the eaves are closed. The projecting front porch extends across the entire front of the house and is supported by square wood posts with decorative brackets at the corners. The tall narrow windows are one-over-one wood sashes with plain wood casings. The house is covered with wide horizontal shiplap siding and rests on a concrete perimeter foundation. It is in poor condition.

P5b. Description of Photo: (View, date, accession #)
residence (View toward west). Photo No: 12-25, 9/14/98

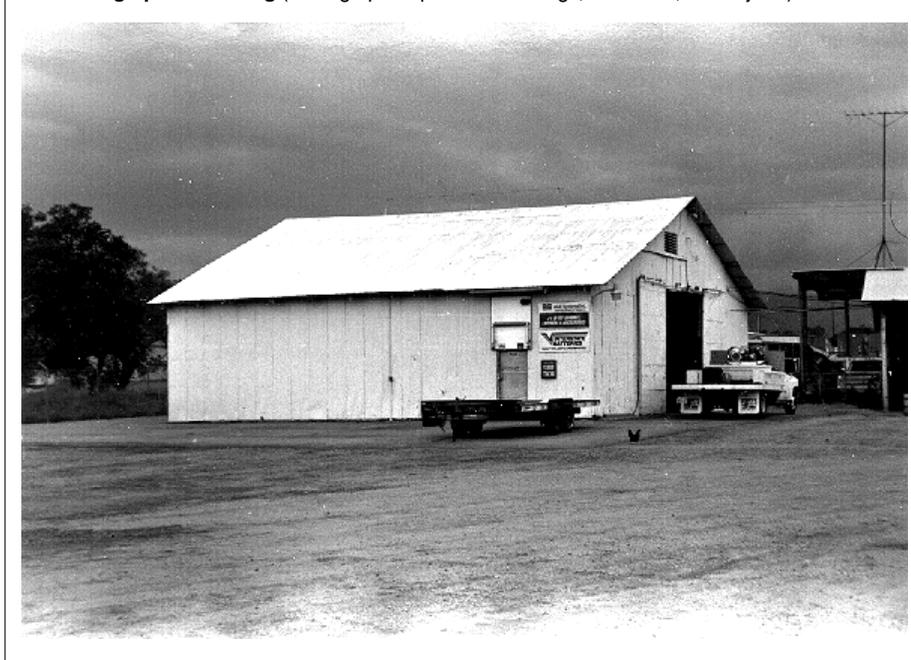
The first building, located adjacent to the creek and west of Telegraph Road, is a tall gable roofed building with a rectangular plan. Above the large sliding door on the east elevation are two large openings that have been boarded up. Other window openings have wood casings and metal bars. The floor is concrete. This building originally was used as the machine shop. The building is in fair condition. A portable trailer is located adjacent to the building on the south side.

P5b. Description of Photo: (View, date, accession #)
storage building (View toward north). Photo No: 2-18, 3/23/98

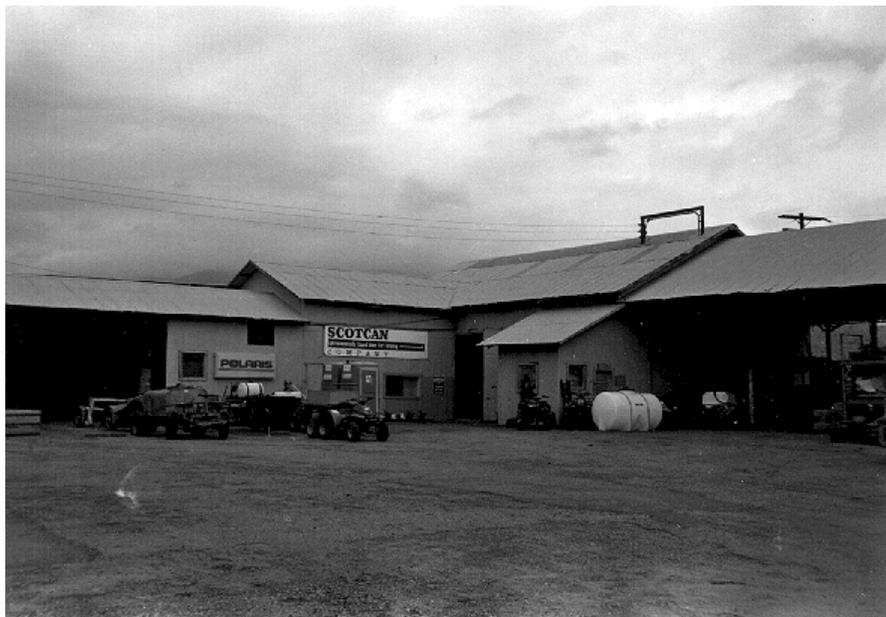
This I-shaped wood frame building is located west of the Santa Paula Creek and behind (north) of the first building described in the previous primary record. The building has intersecting gable roofs with wings on both the west and south sides remaining partially open and covered with corrugated metal roofs supported by wood posts. There are a number of small openings with wood frames surrounding windows and doors. The central portion of the building is covered with corrugated metal siding. This building was originally used as the blacksmith shop. the south wing was added after 1929. The building is in good condition and has retained its architectural integrity.

Blacksmith building (View toward north).

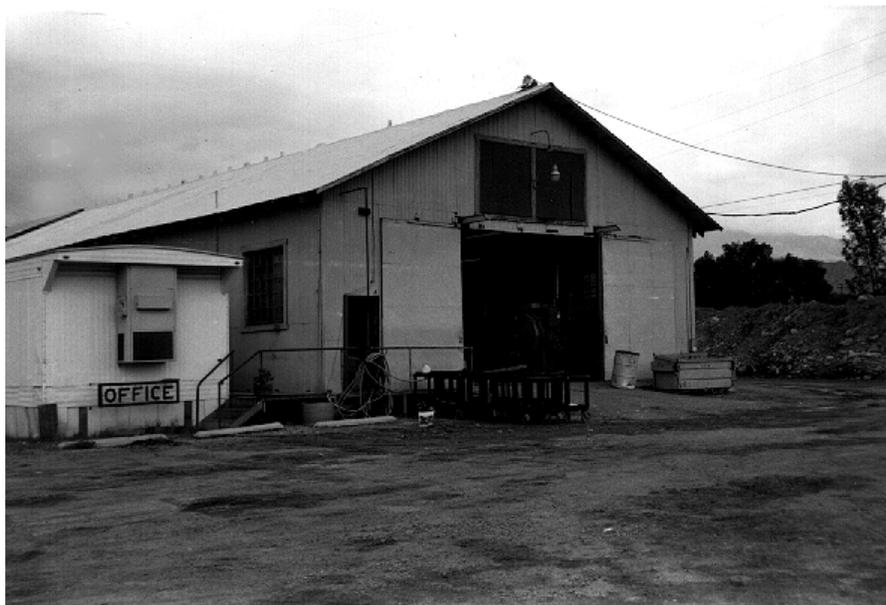
This is the smallest of the three buildings and is located west of the former blacksmith shop. It has a nearly square plan with a medium-high gable roof and corrugated metal siding and roof. Two large doors on the east side operate on a track. The building was originally used to hold oil well supplies. It is in good condition and has retained a high degree of integrity of design and materials as well as setting.

*Machine shop (View toward northeast).
Photo No: 2-20, 3/23/98*
