**GEOLOGIC AND GEOTECHNICAL STUDY EAST GATEWAY PROJECT
LEIGHTON & ASSOCIATES – JULY 12, 2012**

GEOLOGIC AND GEOTECHNICAL STUDY
EAST GATEWAY PROJECT
WITHIN AND EAST OF THE SOUTHEASTERN PORTION OF
THE CITY OF SANTA PAULA,
VENTURA COUNTY, CALIFORNIA

Project No. 032544-001

July 12, 2012

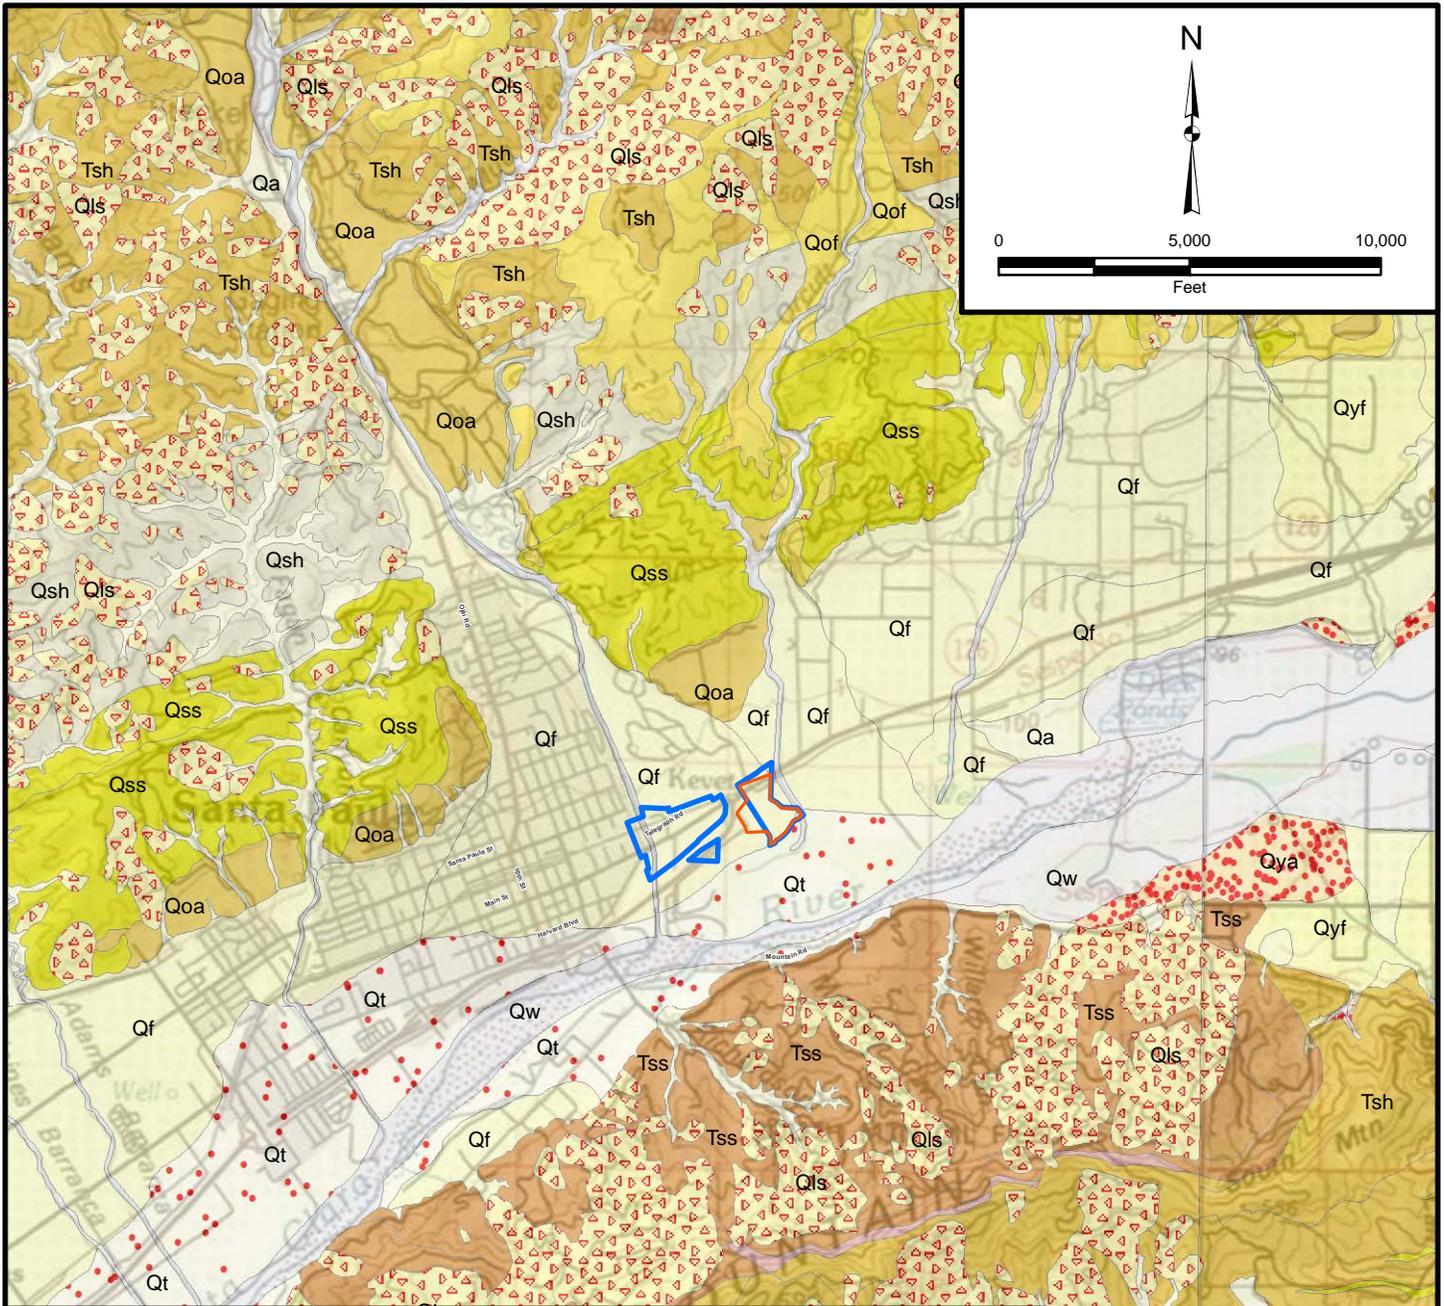
REGIONAL GEOLOGY MAP

Legend	
Qa	Alluvial Valley Deposits
Qf	Alluvial Fan Deposits
Qls	Landslide Deposits; may include debris flows and older landslides
Qoa	Old Alluvial Valley Deposits
Qof	Old Alluvial Fan Deposits
Qsh	Fine-grained formations of Pleistocene age and younger; includes fine-grained sandstone, siltstone, mudstone, shale, siliceous and calcareous sediments
Qss	Coarse-grained formations of Pleistocene age and younger; primarily sandstone and conglomerate
Qt	Terrace Deposits; includes marine and stream terrace deposits
Qw	Alluvial Wash Deposits
Qya	Young Alluvial Valley Deposits
Qyf	Young Alluvial Fan Deposits
Tsh	Fine-grained Tertiary age formations of sedimentary origin
Tss	Coarse-grained Tertiary age formations of sedimentary origin
Tv	Tertiary age formations of volcanic origin

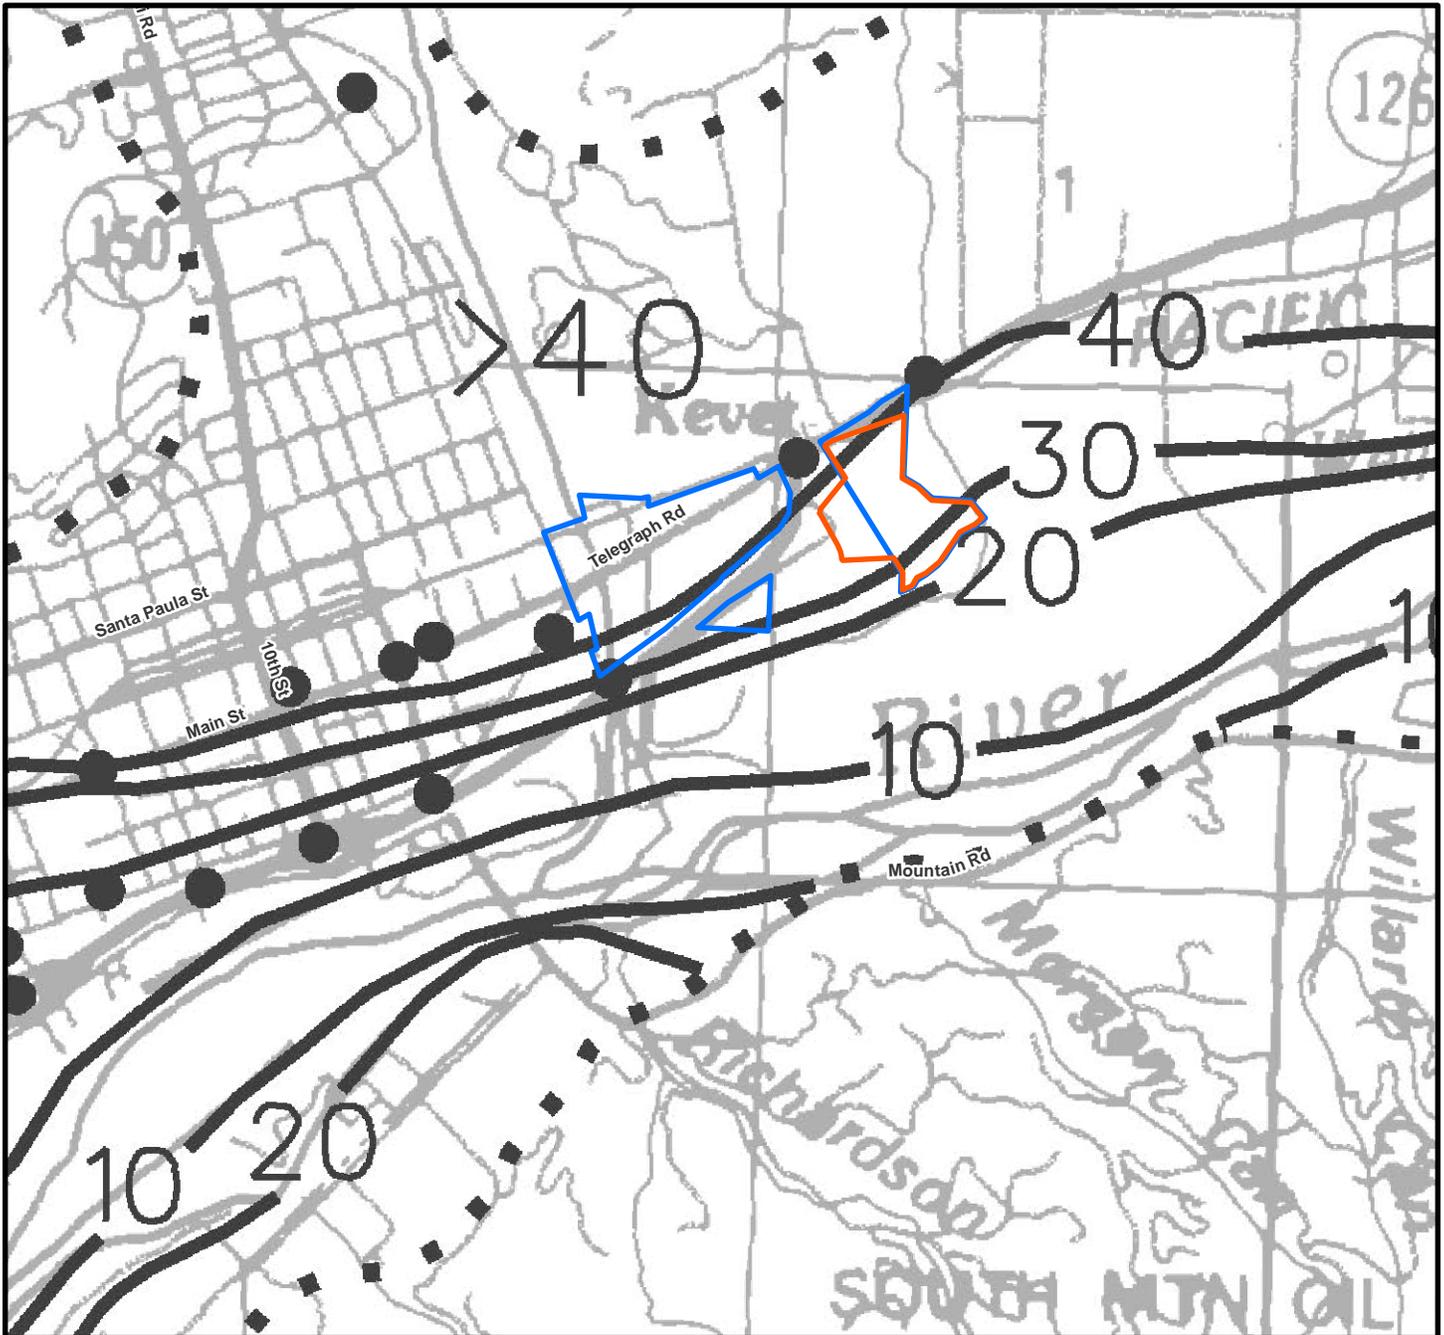
HISTORIC GROUNDWATER DEPTHS
 East Gateway Project
 City of Santa Paula
 Ventura County, California

Project: 032544-001	Eng/Geol: JDH/PB
Scale: 1" = 2,000'	Date: July, 2012
Reference: Plate 1.2, Historically shallowest ground-water depths and borehole locations in alluviated valley areas of the Santa Paula 7.5-minute Quadrangle.

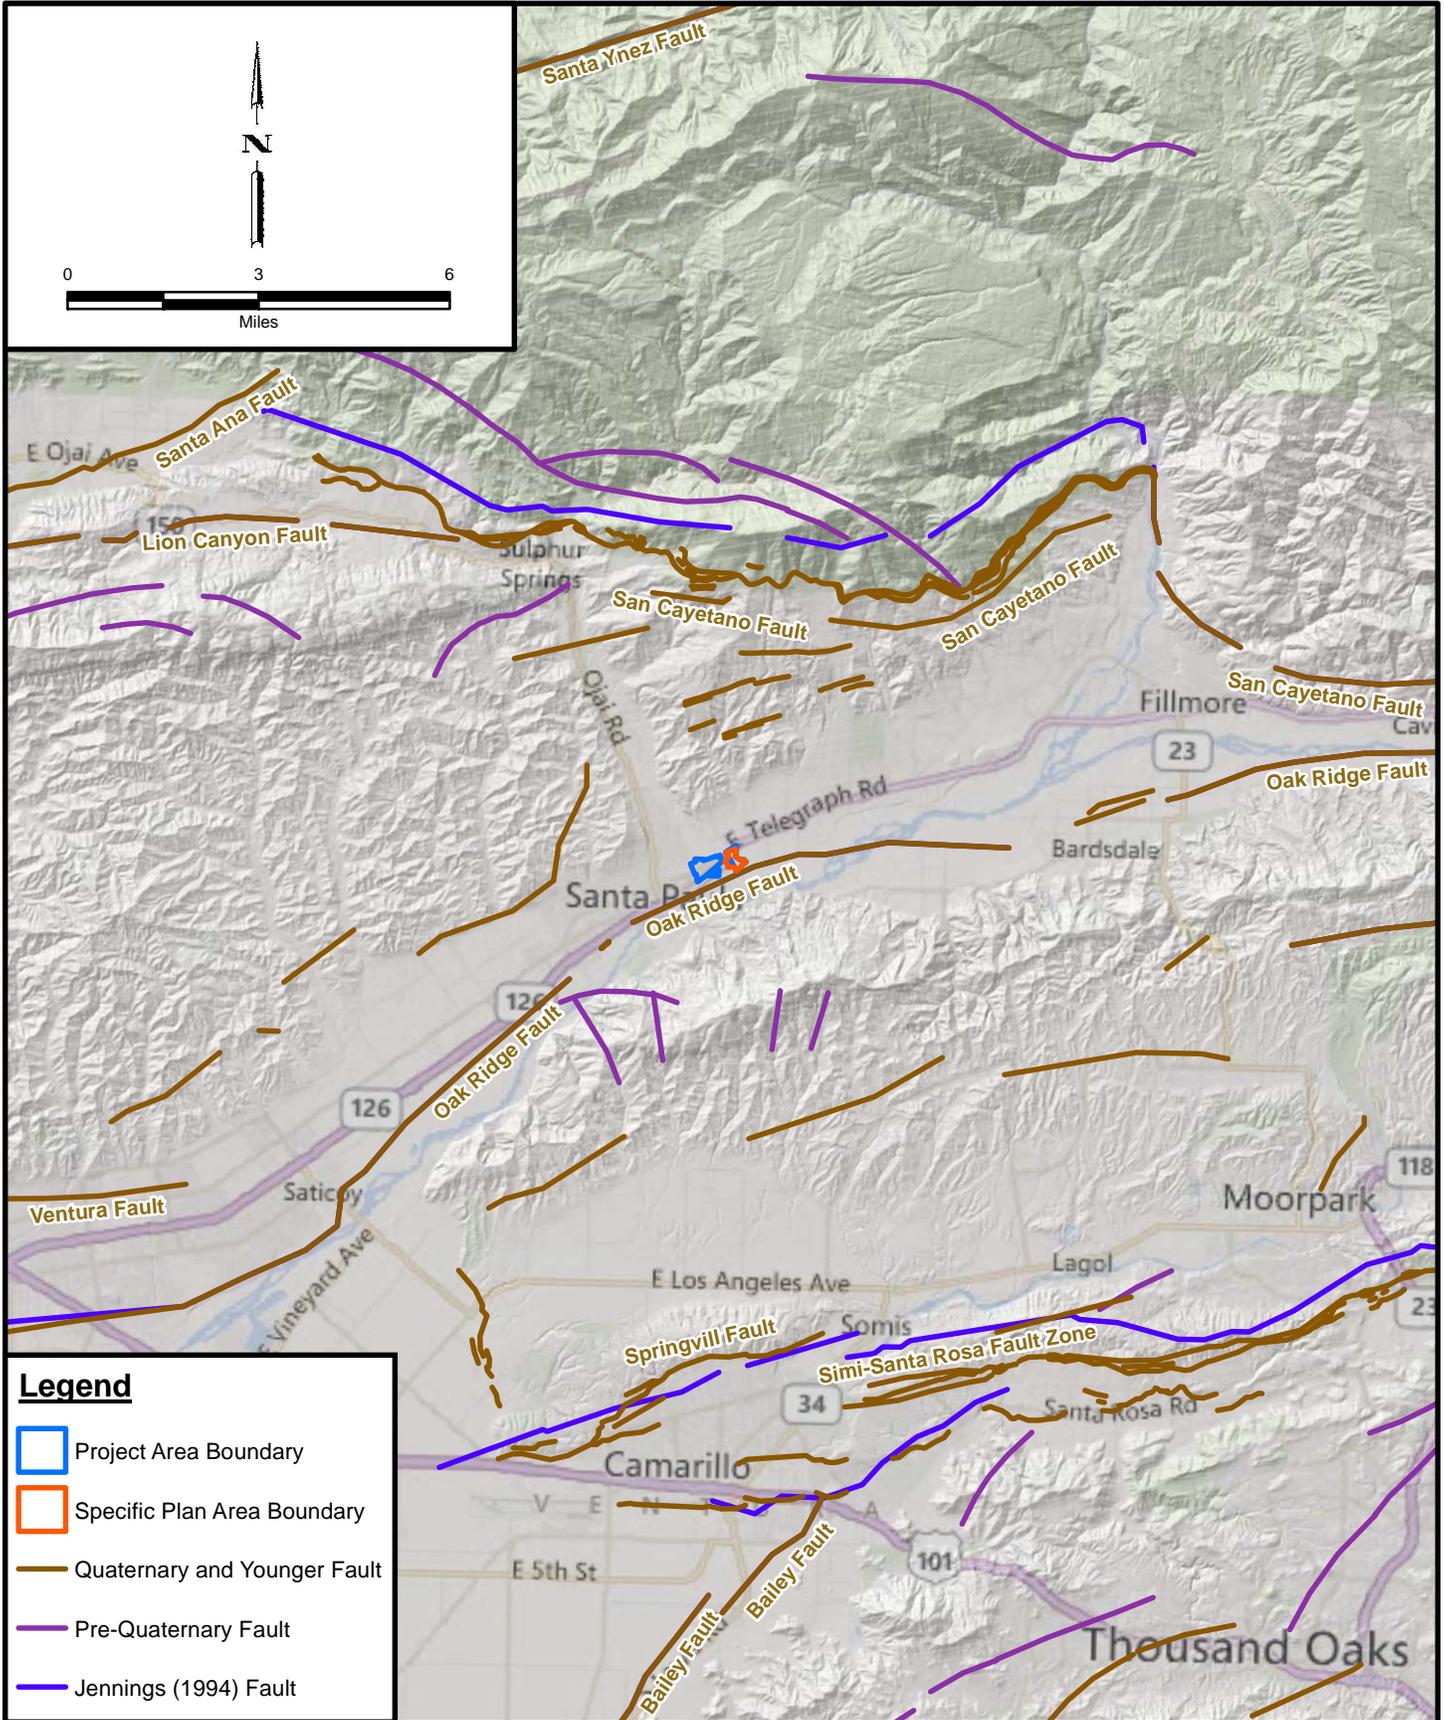
- Project Area Boundary
- Specific Plan Area Boundary
- Quaternary and Younger Fault
- Pre-Quaternary Fault
- Jennings (1994) Fault

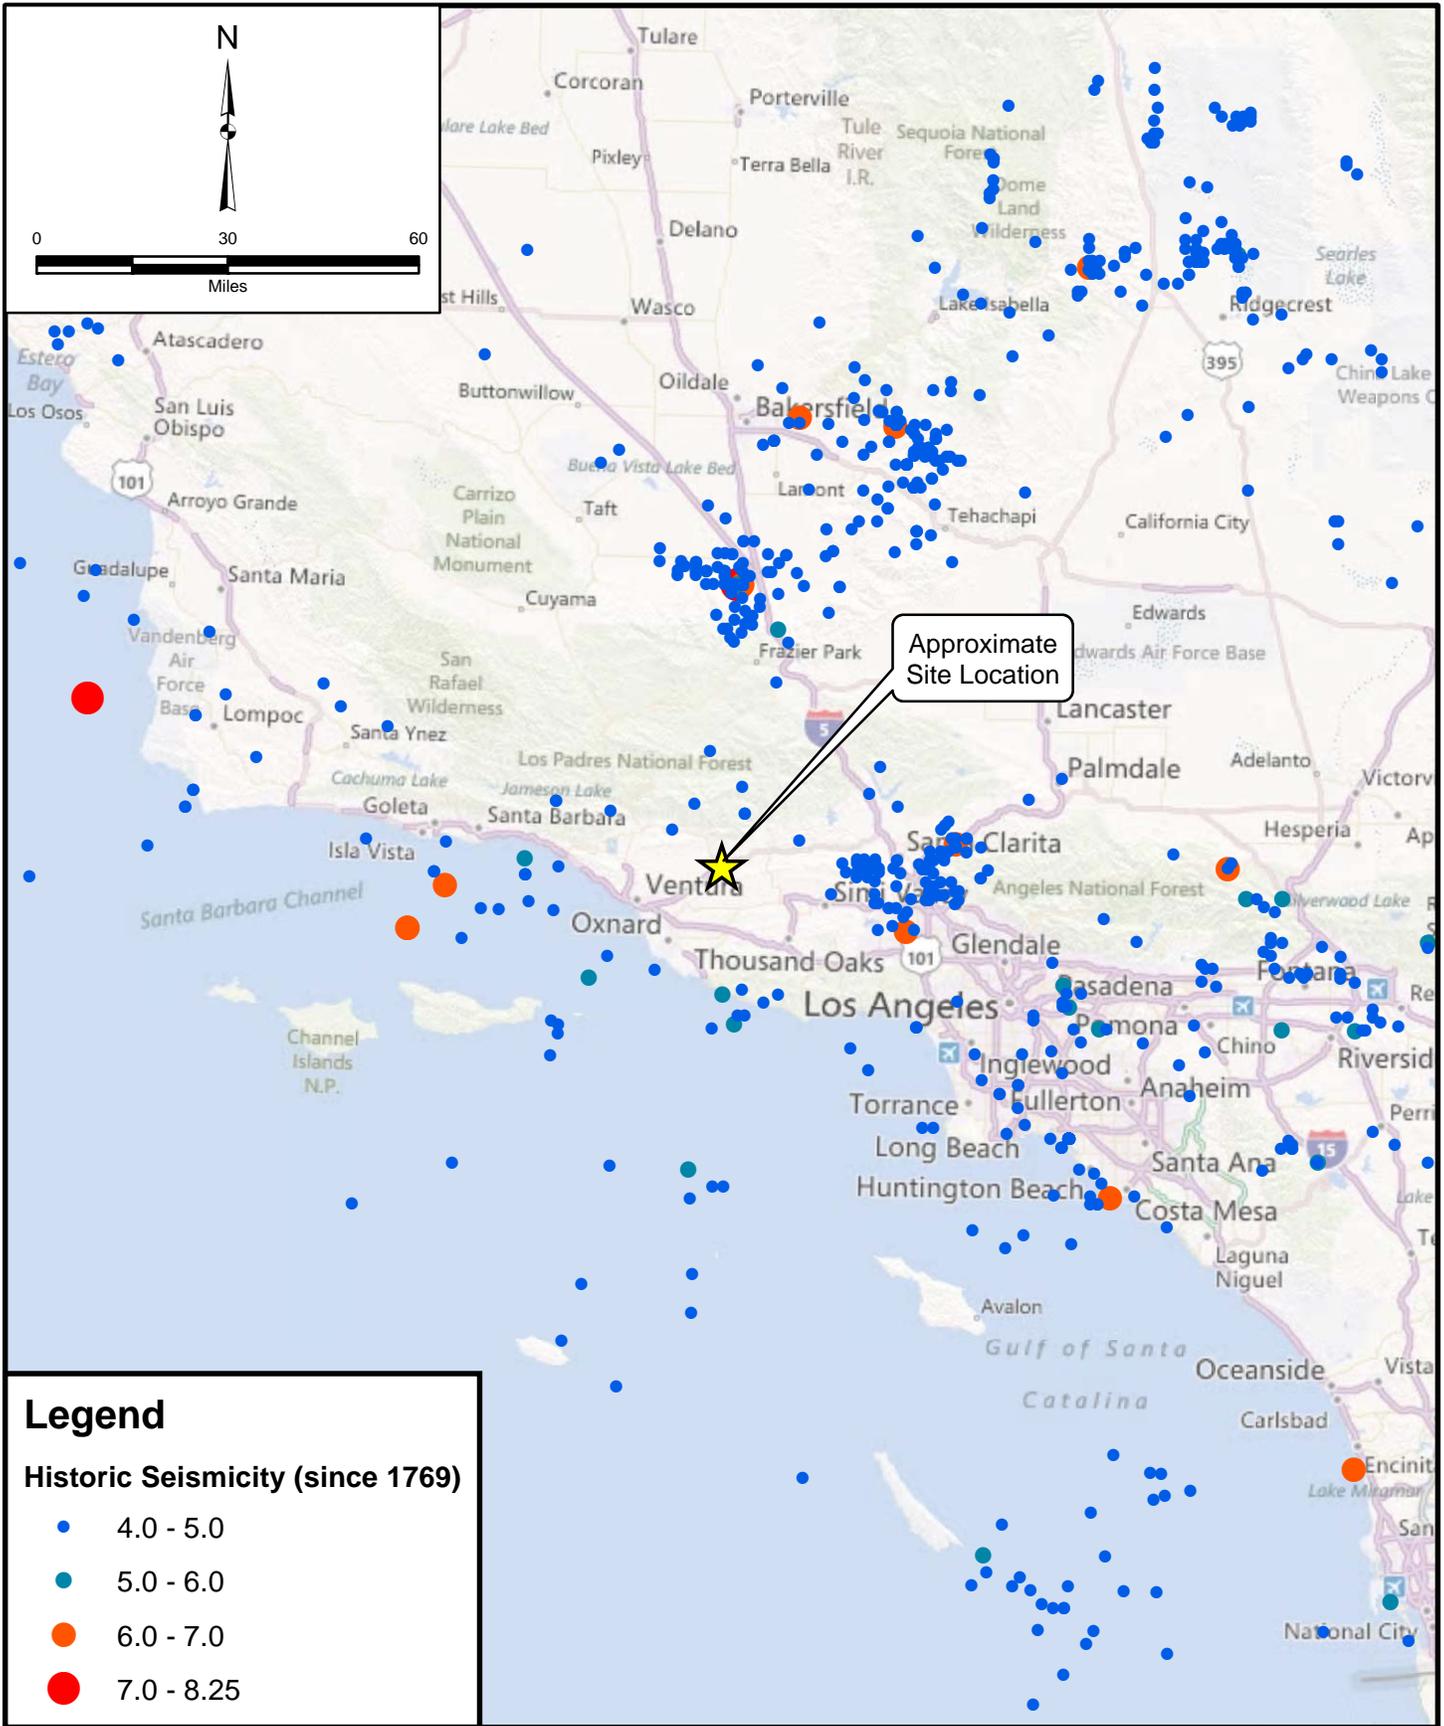
Figure 5

Historic Seismicity (since 1769)

The probability that the Site will be subject to strong seismic shaking from a moderate to large earthquake on a major active fault in southern California is high. The intensity of ground shaking at a given location depends primarily on the earthquake magnitude, faulting mechanism, distance and depth from the source (hypocenter) and the site response characteristics. The intensity of shaking is generally amplified in areas underlain by deep deposits of loose, unconsolidated soils. In the study area, the hazard posed by seismic shaking is considered high, due to the proximity of known active faults. A map showing recent earthquakes in the region is provided as Figure 5.

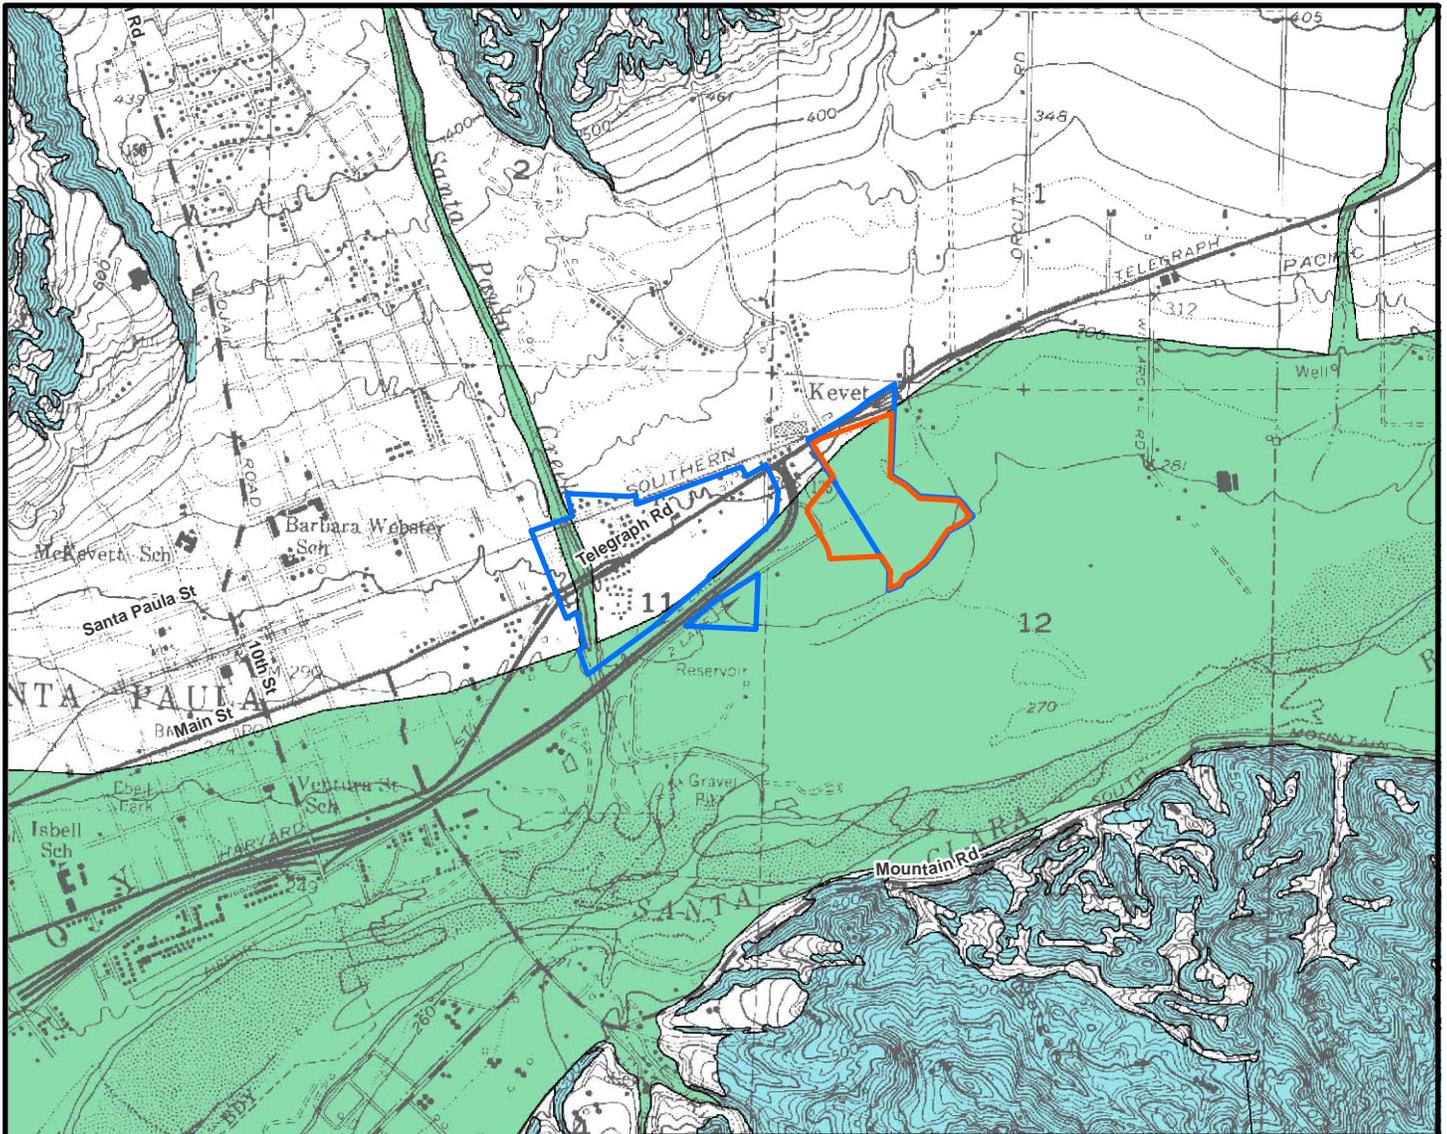
LIQUEFACTION HAZARD MAP
 East Gateway Project
 City of Santa Paula
 Ventura County, California

MAP EXPLANATION
Zones of Required Investigation:

Areas where historical occurrence of liquefaction, or local geological, geotechnical and ground-water conditions indicate a potential for permanent ground displacements such that mitigation as defined in Public Resources Code Section 2693(C) would be required.

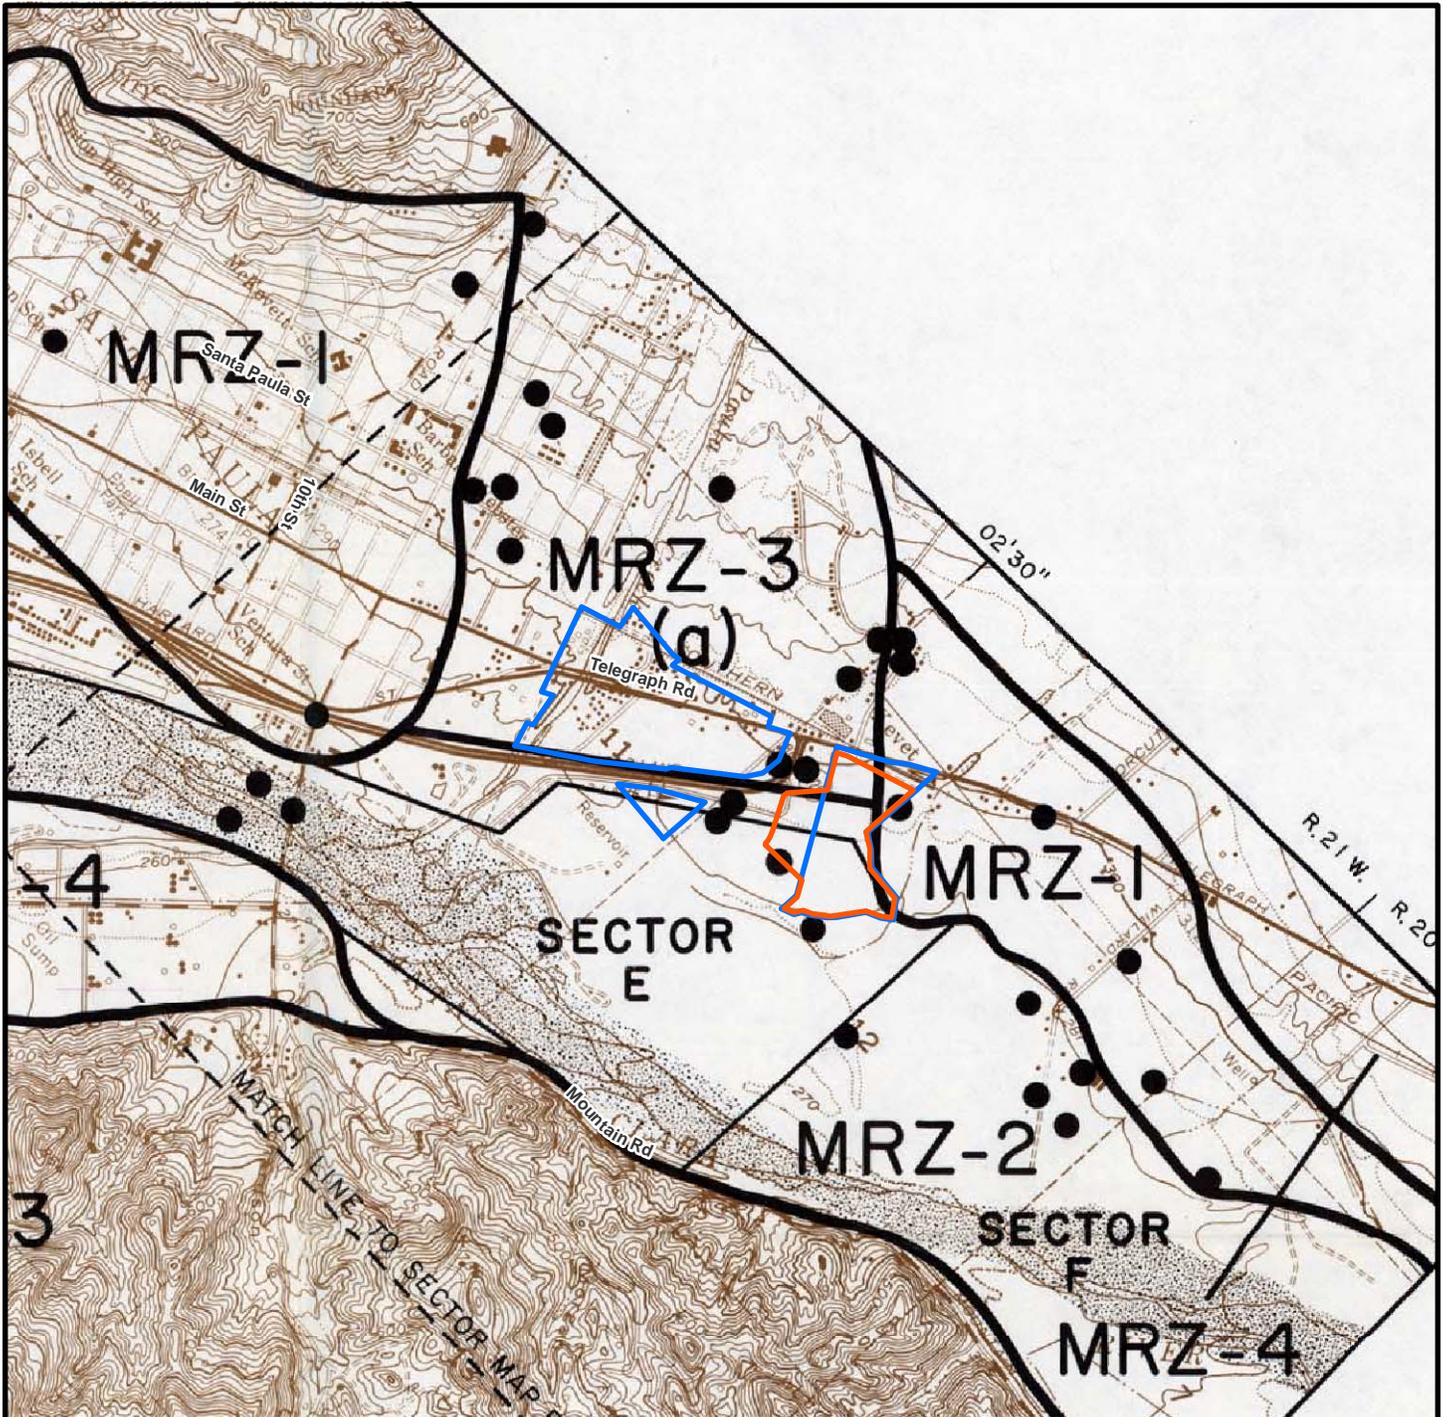
- Drill Hole
- Area underlain by extractable sand and gravel (Resource Sector)
- ▨ Riverbed
- MRZ-2 MRZ Line
- Project Area Boundary
- Specific Plan Area Boundary

The requirements of the California Surface Mining and Reclamation Act of 1975 are such that full consideration has to be given to the potential loss of significant mineral deposits to land uses that preclude mining. The primary mineral resource in the Santa Paula area is aggregate (sand and gravel) mined from the Santa Clara River wash adjacent to the south of the Site (Anderson, et al., 1981; City of Santa Paula, 1998b). The aggregate resource is in high demand because much of the material mined from the Santa Clara River meets California Department of Transportation standards for Portland cement concrete aggregate. The aggregate mines are also important to flood control along the Santa Clara River. Removal of material from the River is controlled by the Ventura County Flood Control District to ensure that the optimum stream gradient is maintained. Therefore, CGS has defined the Western Ventura County Production-Consumption Region within which the likelihood for the presence or absence of mineral deposits has been estimated. The Site lies within this Production-Consumption Region. The vast majority of the Site lies within Mineral Resource Zones 2 and 3 (MRZ-2 and MRZ-3) with a small portion in Mineral Resource Zone 1 (See Figure 7).

The locations of MRZ-1, MRZ-2, MRZ-3 and MRZ-2, Sector E with respect to the Site are shown in Figure 7.

Extractable sand and gravel deposits suitable for use as aggregate have been identified within the Western Ventura County Production-Consumption Region and characterized as Resource Sectors within MRZ-2 (Anderson, et al., 1981). Most of the Project Area of the Site south of State Route 126 and north of Lemonwood Drive, and approximately the southern portion of the Specific Plan Area (and corresponding portions of the Project Area) in the eastern and southern parts of the Site lie within MRZ-2 Sector E and a City of Santa Paula-recognized aggregate resource area (City of Santa Paula, 2010). These areas are relatively small and development of the Site does not preclude future mining of mineral resources. As such the potential loss of mineral resources is considered to be less than significant.
